Introduction

Design, construction, and installation of the ram pump

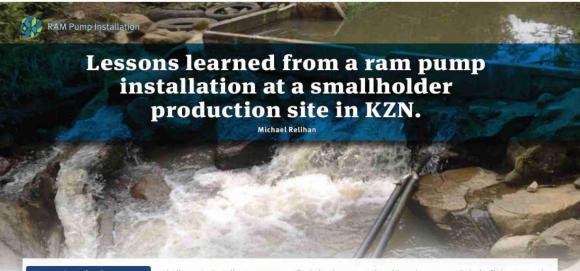
I made an impulse valve similar to that of the Papua New Guinea ram pump design from a 3-inch stainless steel nipple cut in half and other stainless steel parts. It had springs flanking its bush, and large weights were initially fitted. I internalized the nonreturn valve within the pressure chamber (as in many ram pump designs) to avoid exposing the brass delivery non-return valve to great leverage forces due to any drive pipe movement. The pressure chamber was made of galvanized iron and mounted horizontally. A small snifter valve

was made in the fitting connecting the impulse valve and pressure chamber to which the non-return valve fitted inside the pressure chamber (Fig. 1).

The performance of the ram pump was initially inadequate as it often stopped pumping and its output pressure was too low. The impulse valve worked better after removing the large weights, installing suitable springs and adjusting the locking nut position. Increased pumping pressure came from lengthening the drive pipe and moving the stand pipe upstream. Initially there was also poor flow through the siphon pipe due mostly to air-lock, but also sediment accumulation, caused by vertical undulation of the pipe, and much better flow was achieved after re-routing it in the river with minimal vertical undulation. Another siphon pipe was installed much later to improve flow rate (Fig. 4). The siphon pipes were joined at their lower ends to a 75mm pipe for connection to the stand pipe.

Assembled ram pump. Initially the impulse valve (bottom left) was fitted with disk-weights which were removed later as it operated better without them. Operation after installation shown bottom right
